Historic Road Bridges

Fingal County Council

Volume 2
Built Heritage &
Ecological Inventory of Bridges

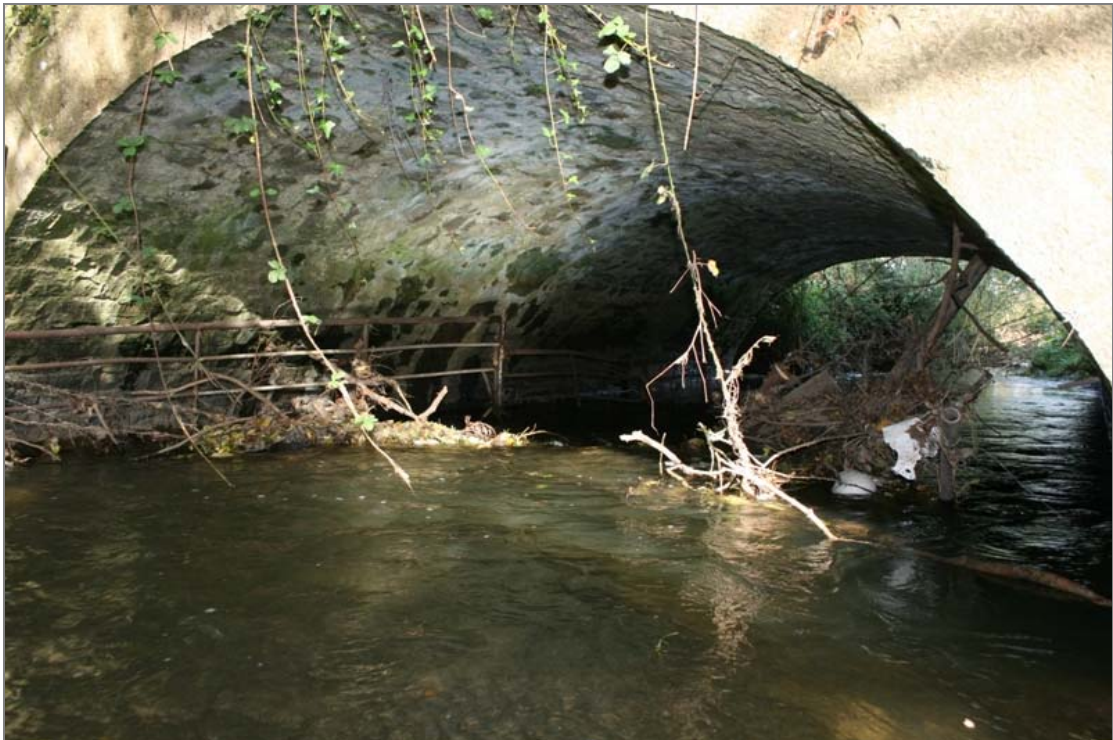
localised areas of spandrels and parapet.
Condition (soffit)	Generally good; no obvious major water penetration, some small scale crystallisation of minerals.
Grouting or spray concrete?	No
Grouting or spray commentary	n/a
Accessibility	Accessible from all but north east side which was on private land. Vegetation obscured views from west banks.
Built heritage photographs	FHBS-02-BH-01 ~ South upstream elevation FHBS-02-BH-02 ~ North downstream elevation FHBS-02-BH-03 ~ North parapet from road FHBS-02-BH-04 ~ Large Ash tree rooted on stone-built west bank just upstream of south elevation FHBS-02-BH-05 ~ Arch soffit from south FHBS-02-BH-06 ~ General view of bridge from southeast
Name of Built Heritage Field Surveyor	Eamonn Hunter
Date of inspection (Built Heritage)	22-10-08
Built heritage commentary	This well-constructed stone bridge appears early-mid nineteenth century in date based simply on its good condition (despite damaged parapet wall tops), although it may be earlier or be a replacement for a previous structure on the site as the mill here is older. Located on a very quiet road with relatively little traffic using it, it is a structure of local significance with historic interest. Previously surveyed 10-6-80; 7-7-95; 9-11-99

FHBS-02-BH-05 ~ Arch soffit from south

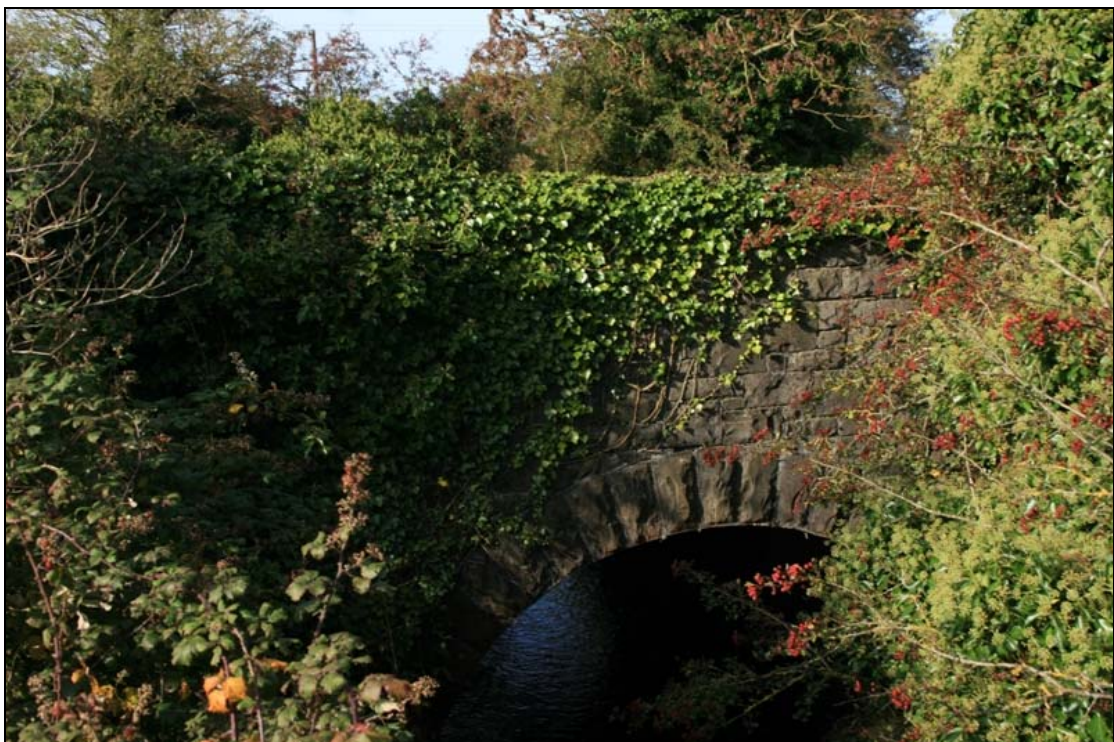
FHBS-04-NH-02 ~ Ivy coverage

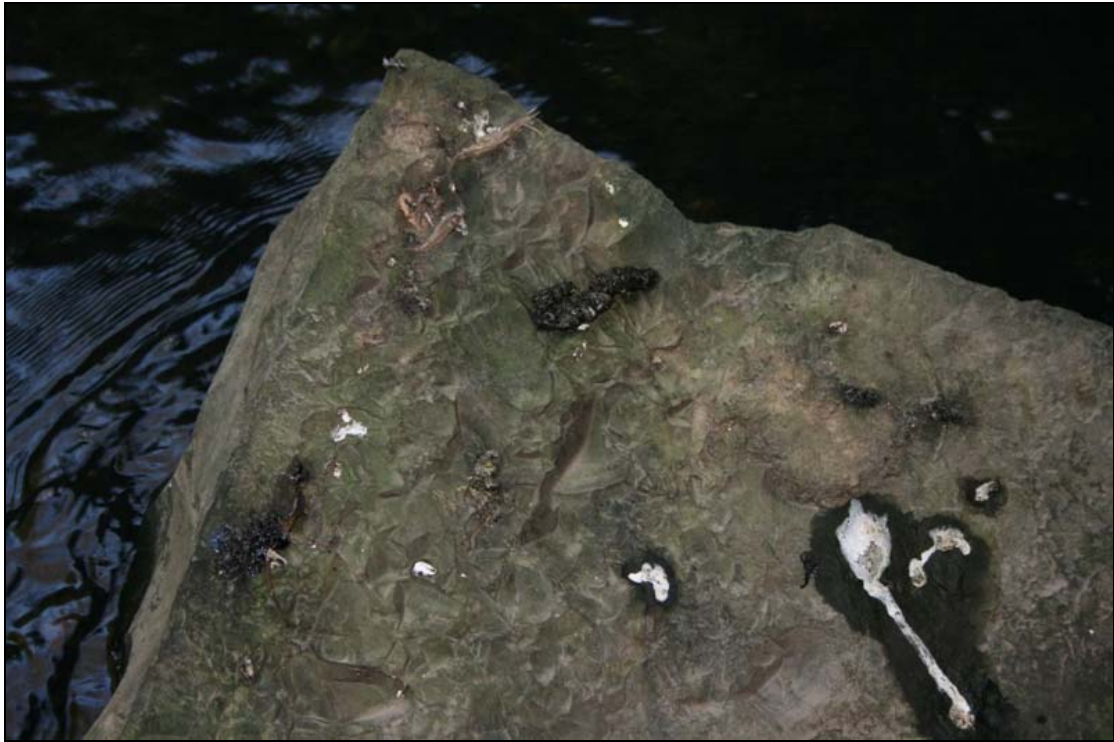
FHBS-04-NH-03 ~ Otter spraint.

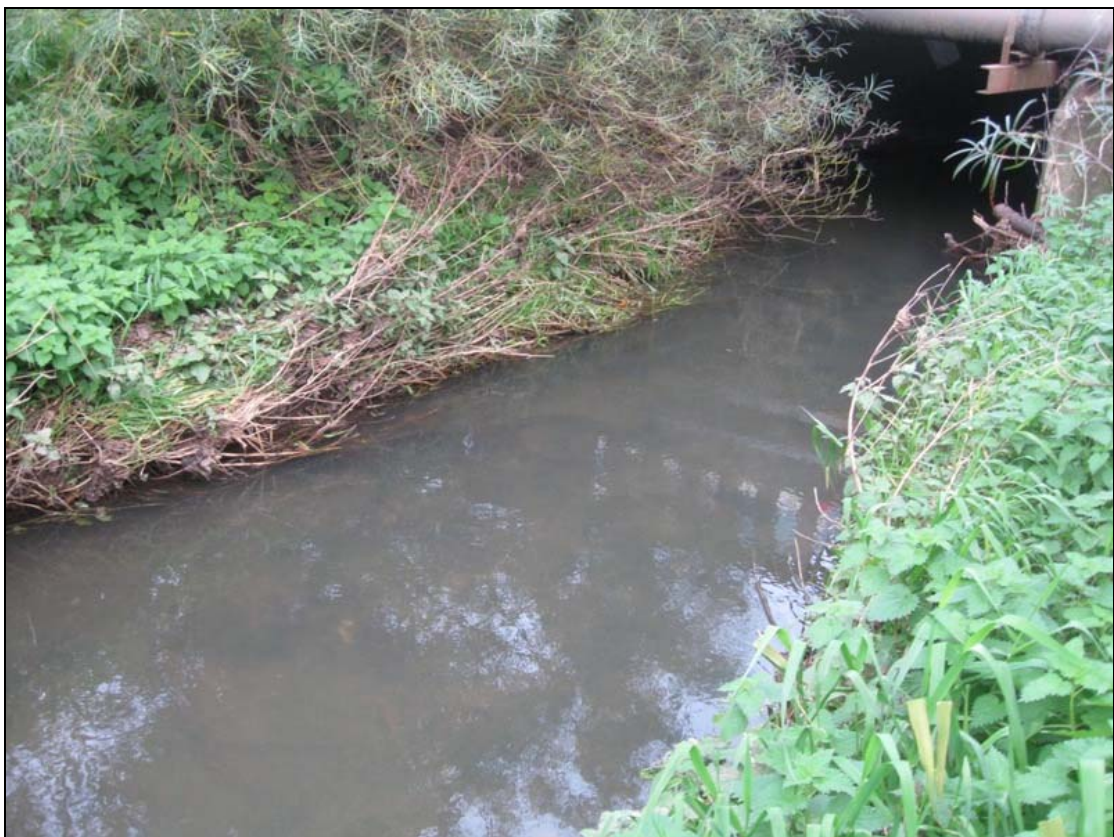
FHBS-06-NH-03 ~ Nutrient enriched/ eutrophic river water

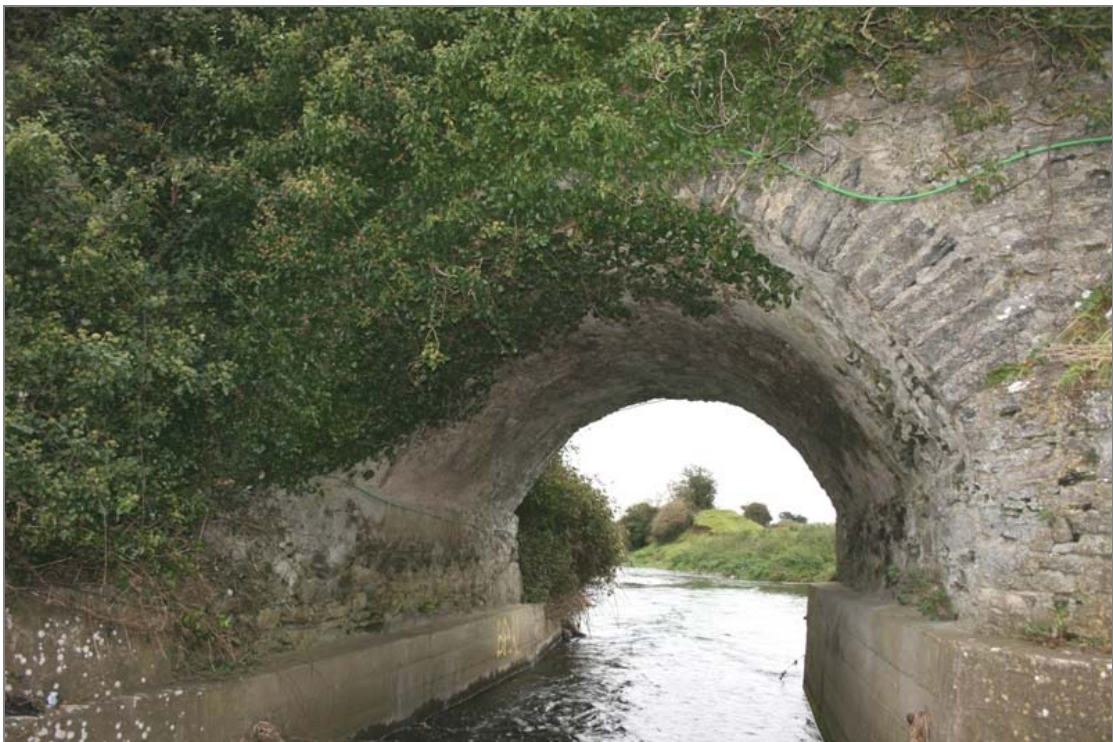
FHBS-07-BH-06 ~ Northern archway from west

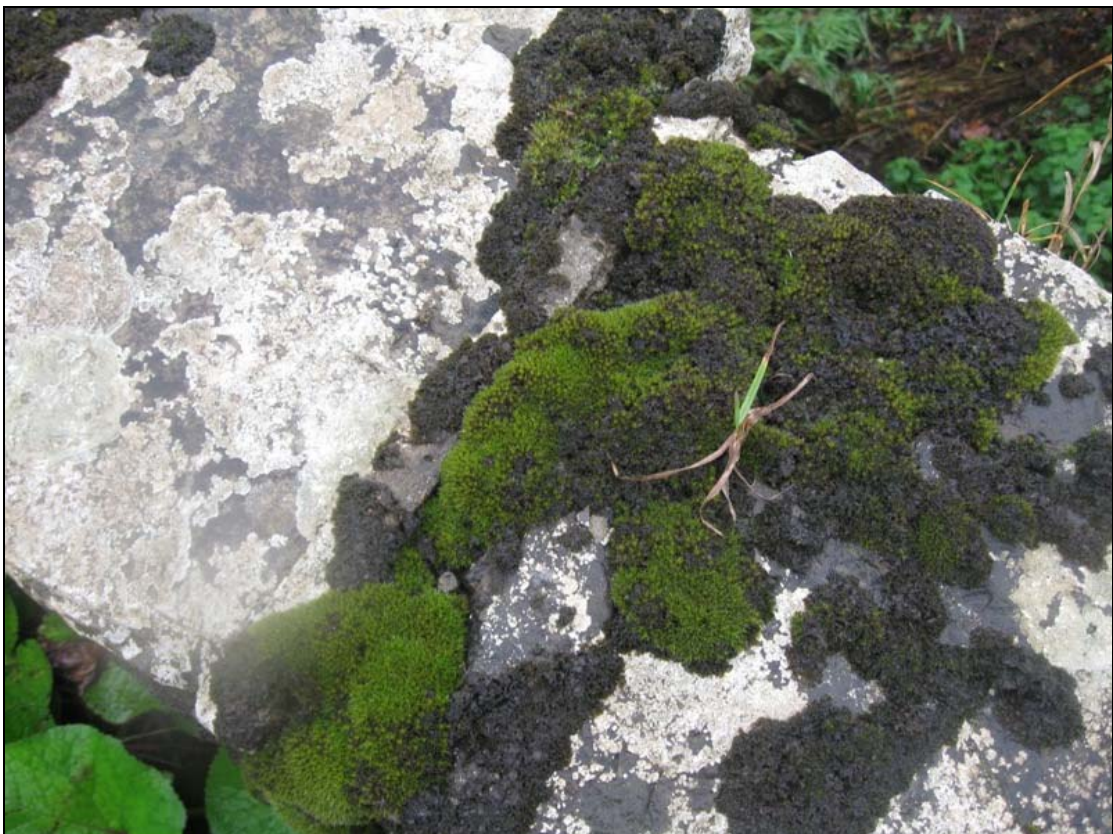
FHBS-12-NH-02 ~ Bryophyte growth on bridge wall

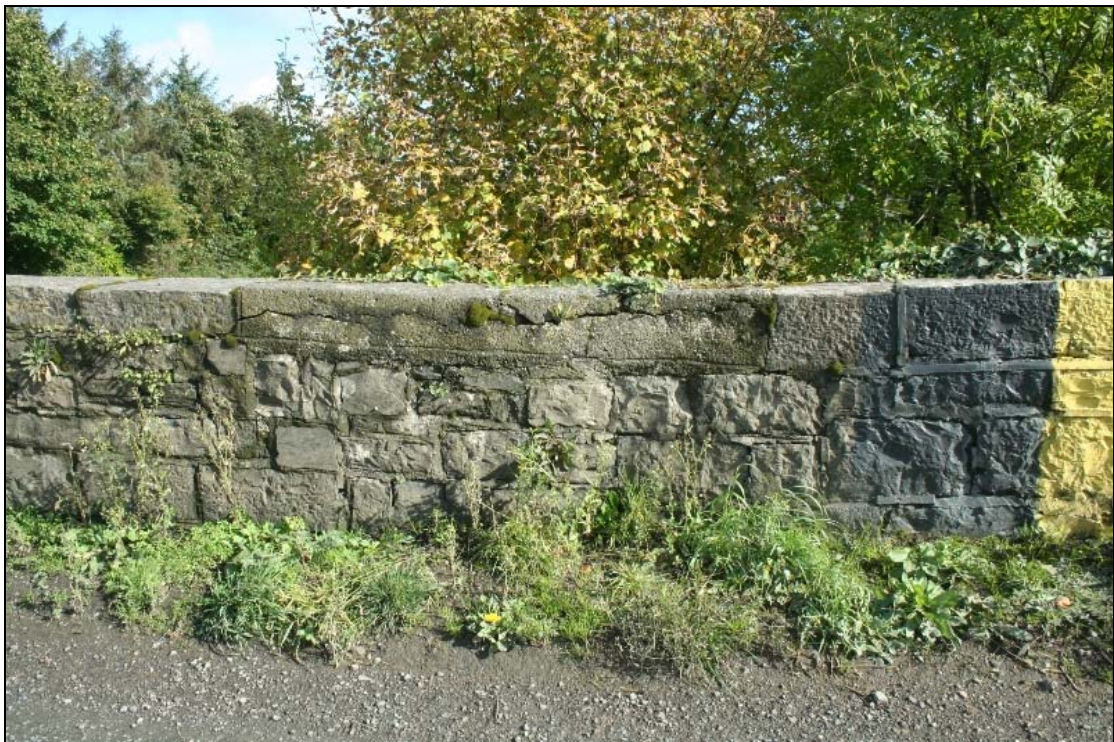
FHBS-15-BH-04 ~ Detail of east parapet of canal bridge from road

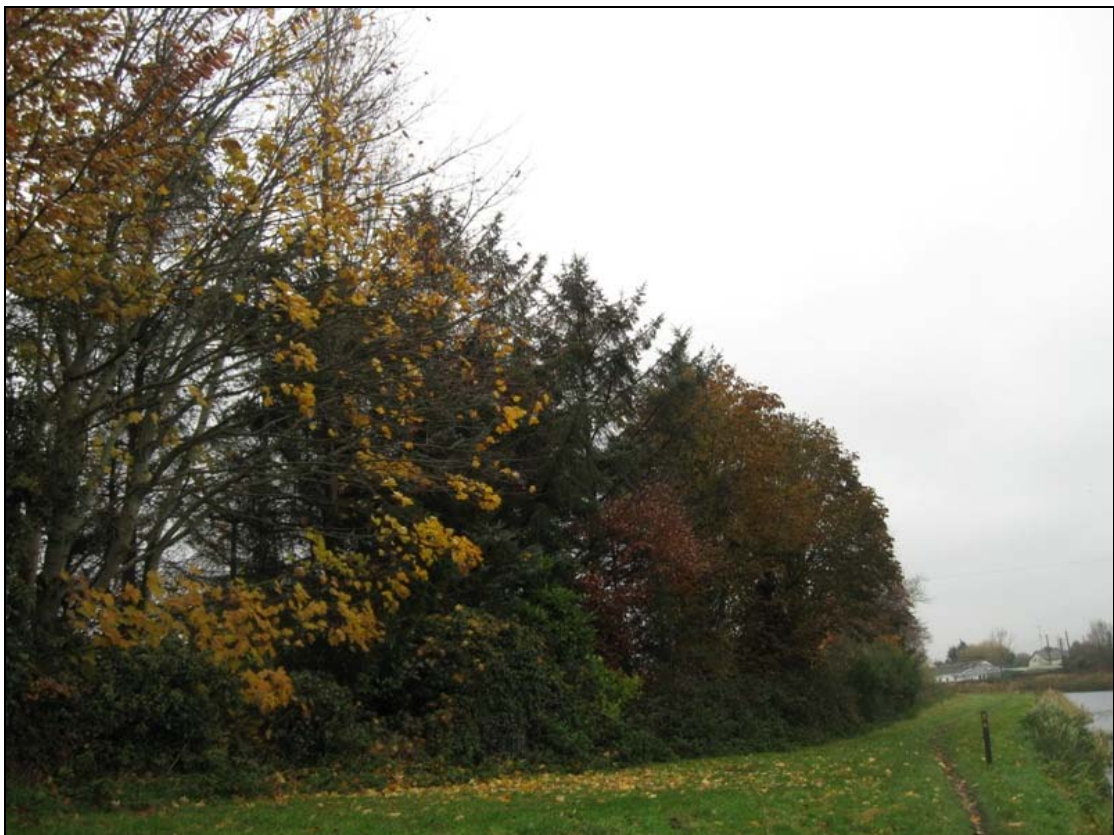
FHBS-15-NH-02 ~ Treeline downstream of the bridge

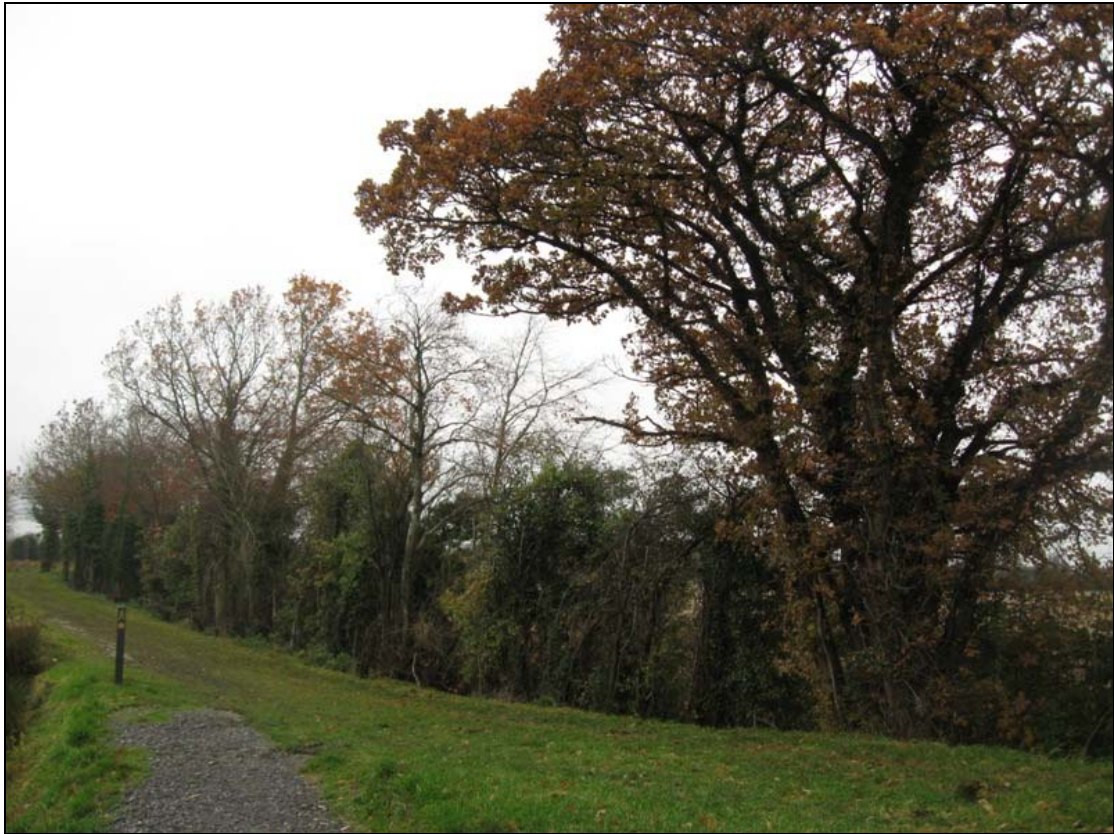
FHBS-15-NH-03 ~ Treeline situated on the margins of the bridge structure
